**Flood Control Project Maintenance
Levee Inspections
LMA District Cover Sheet
Spring 2010 Levee Inspection Results**

San Joaquin County Flood Control and Water Conservation District

Spring 2010 Levee Inspection Results

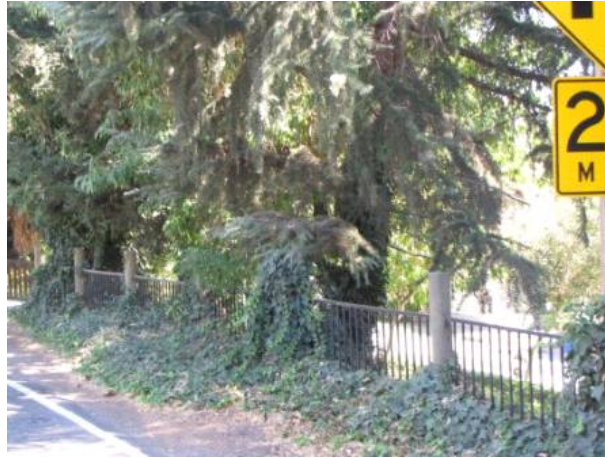
View of a fence and landscaping along the landward shoulder and slope looking upstream.

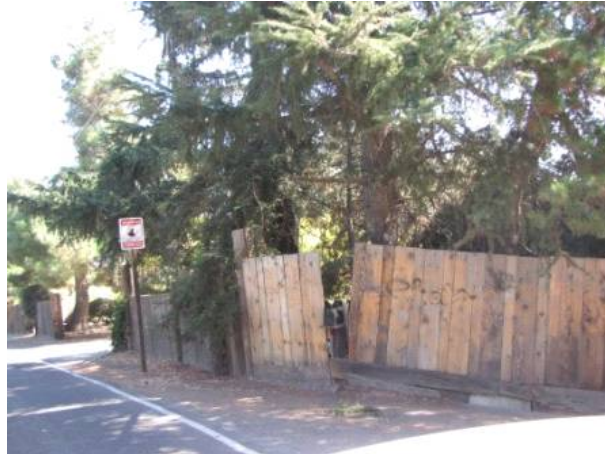
Levee Mile Report Line	146
Start Levee Mile	22.19
End Levee Mile	22.21
Location	Land Side
Category	Earthen Levee
Item	Encroachments

View of a fence along the landward shoulder and slope looking upstream.

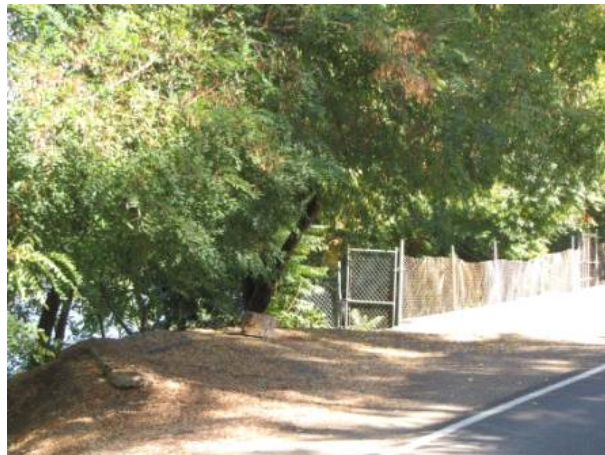
Levee Mile Report Line	147
Start Levee Mile	22.19
End Levee Mile	22.21
Location	Water Side
Category	Earthen Levee
Item	Encroachments

View of a fence along the waterward shoulder and slope looking upstream.

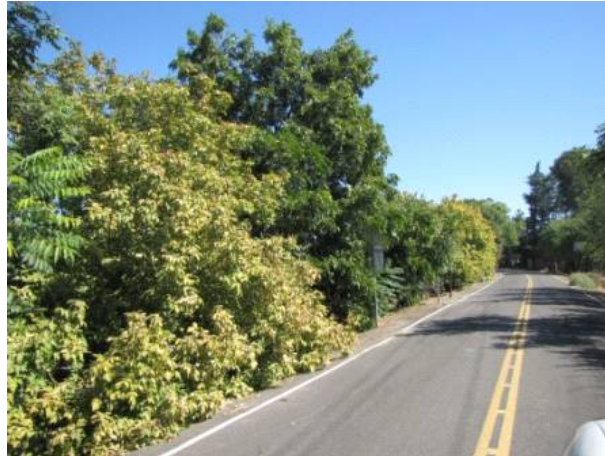
View of trees along the waterward slope obstructing visibility and access looking upstream.

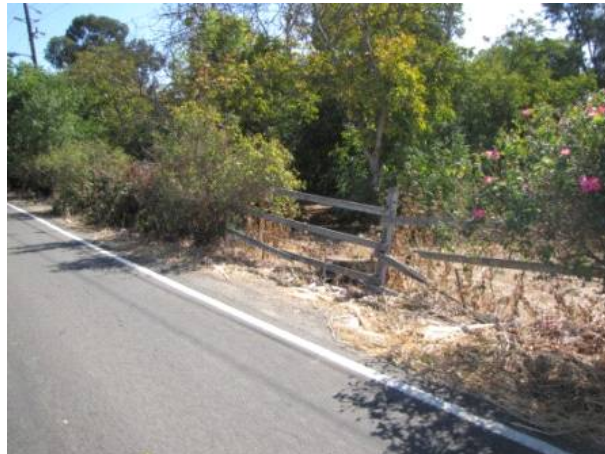
Levee Mile Report Line	149
Start Levee Mile	22.26
End Levee Mile	22.30
Location	Land Side
Category	Earthen Levee
Item	Encroachments

View of a fence along the landward shoulder looking upstream.

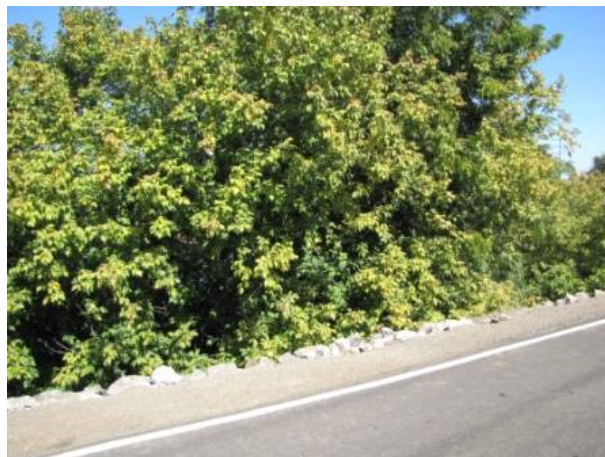
Levee Mile Report Line	150
Start Levee Mile	22.31
End Levee Mile	22.31
Location	Water Side
Category	Earthen Levee
Item	Trim / Thin Trees

View of trees on the waterward slope obstructing visibility and access looking upstream.

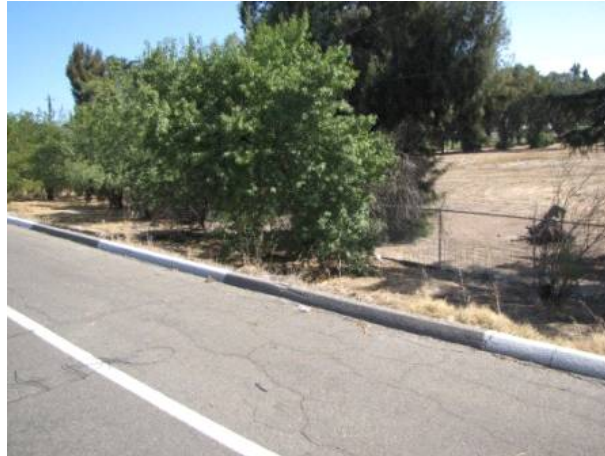
Levee Mile Report Line	152
Start Levee Mile	22.37
End Levee Mile	22.43
Location	Land Side
Category	Earthen Levee
Item	Encroachments
View of fence and landscaping along landward slope looking upstream.	
dpesaven_s_20100316_362.jpg

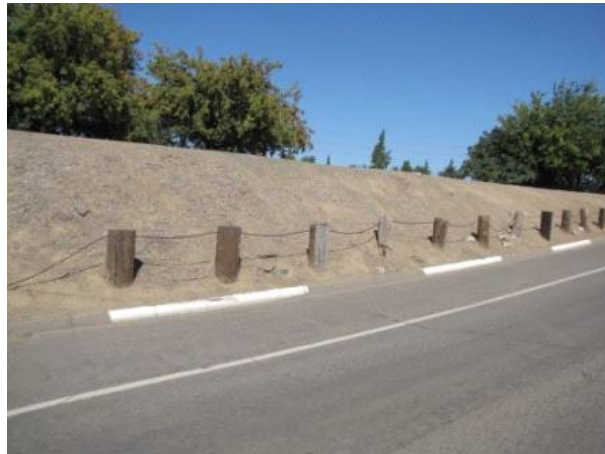
Levee Mile Report Line	153
Start Levee Mile	22.43
End Levee Mile	22.46
Location	Land Side
Category	Earthen Levee
Item	Encroachments
View of a post and cable fence along the landward slope looking upstream.	
dpesaven_s_20100316_361.jpg

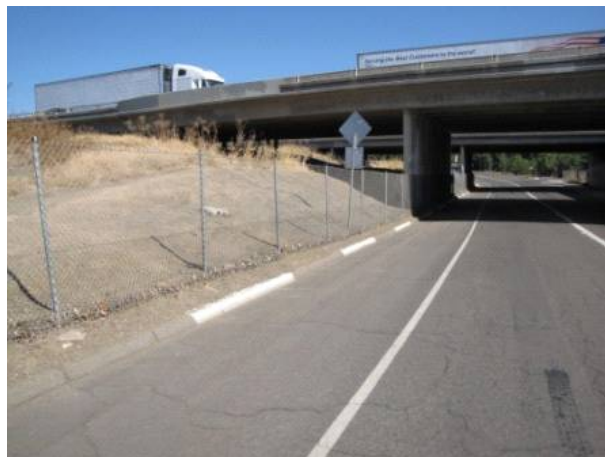
Levee Mile Report Line	154
Start Levee Mile	22.46
End Levee Mile	22.52
Location	Land Side
Category	Earthen Levee
Item	Encroachments
View of fence along landward toe looking upstream.	
dpesaven_s_20100316_360.jpg

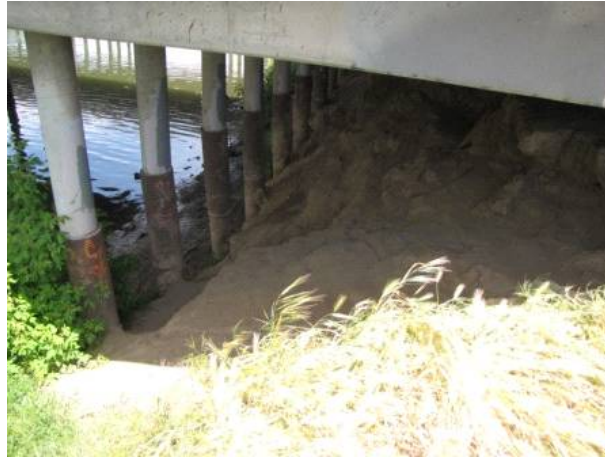
dpesaven_s_20100518_589.jpg

View of erosion on the waterward slope under I-5 looking upstream.

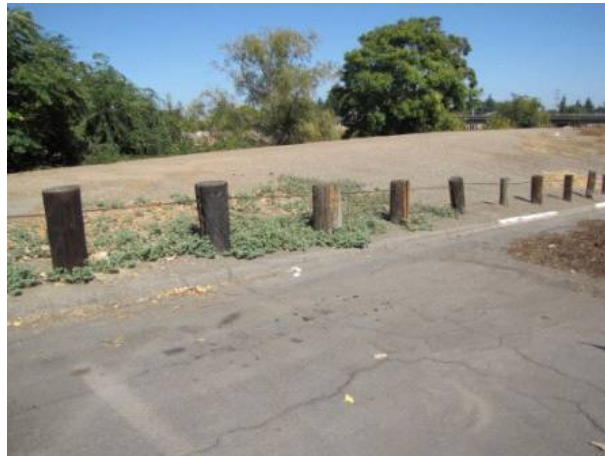
Levee Mile Report Line	156
Start Levee Mile	22.52
End Levee Mile	22.57
Location	Land Side
Category	Earthen Levee
Item	Encroachments

View of post and cable fence along the landward levee slope looking upstream.

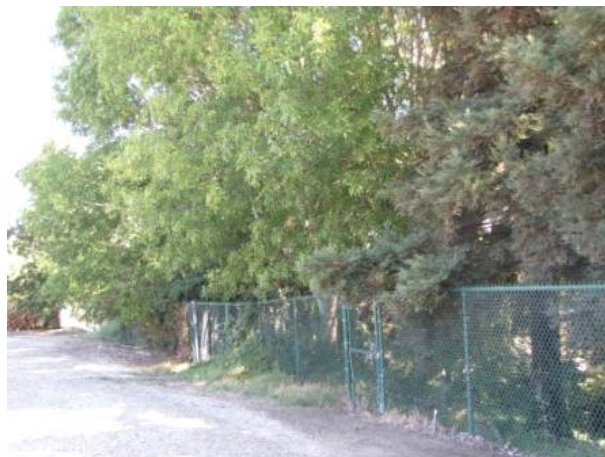
Levee Mile Report Line	158
Start Levee Mile	22.58
End Levee Mile	22.87
Location	Land Side
Category	Earthen Levee
Item	Encroachments

View of fence and landscaping along the landward shoulder and slope looking upstream.

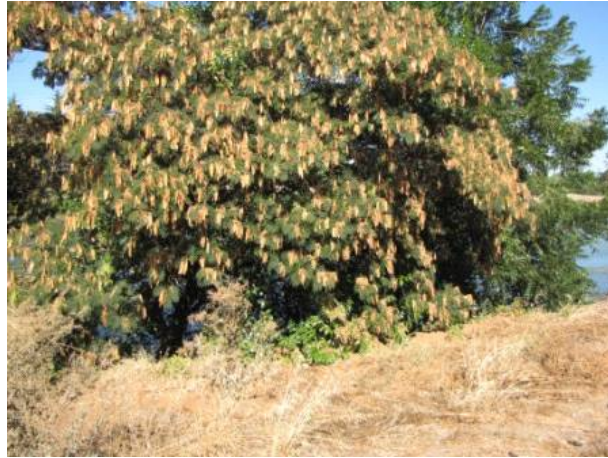
dpesaven_s_20100316_358.jpg

View of a tree blocking visibility and access along the waterward slope.

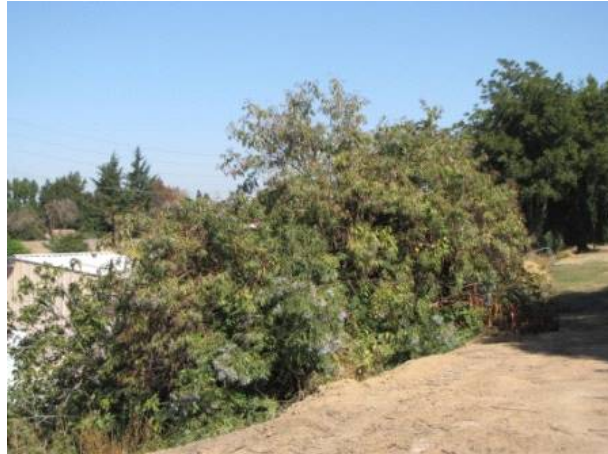
Levee Mile Report Line	160
Start Levee Mile	22.86
End Levee Mile	22.86
Location	Land Side
Category	Earthen Levee
Item	Vegetation

View of elderberry bushes along the waterward slope looking upstream.

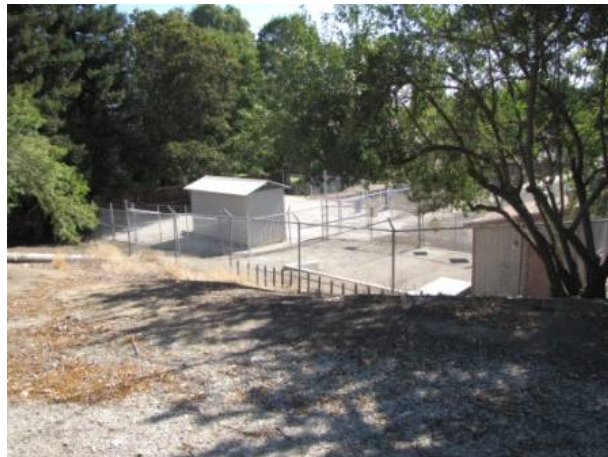
Levee Mile Report Line	161
Start Levee Mile	22.87
End Levee Mile	22.89
Location	Land Side
Category	Earthen Levee
Item	Encroachments

View of fence along the landward slope.

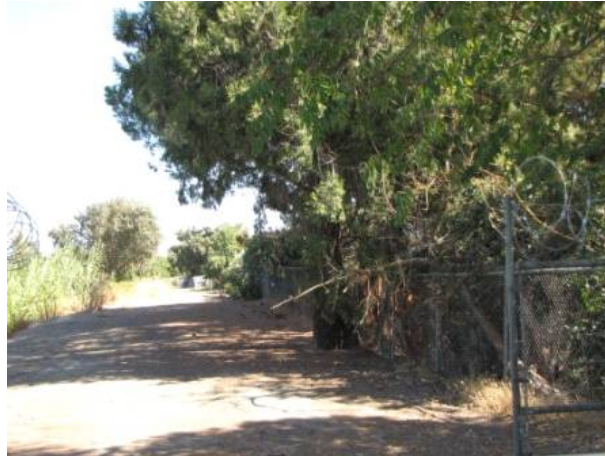
dpesaven_s_20100316_353.jpg

View of fence and landscaping along the landward shoulder looking upstream.

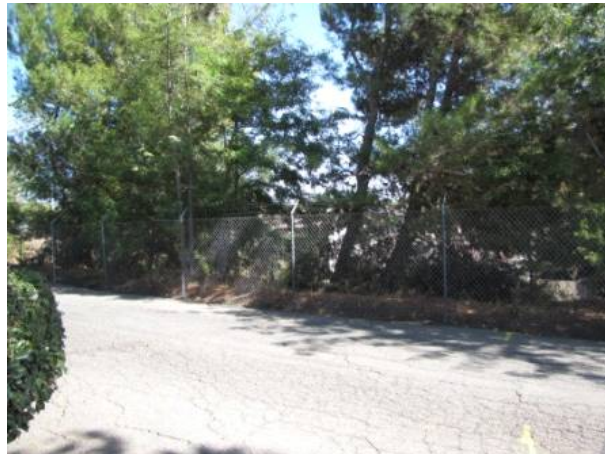
Levee Mile Report Line	166
Start Levee Mile	23.08
End Levee Mile	23.22
Location	Land Side
Category	Earthen Levee
Item	Encroachments

View of fence along the landward shoulder looking upstream.

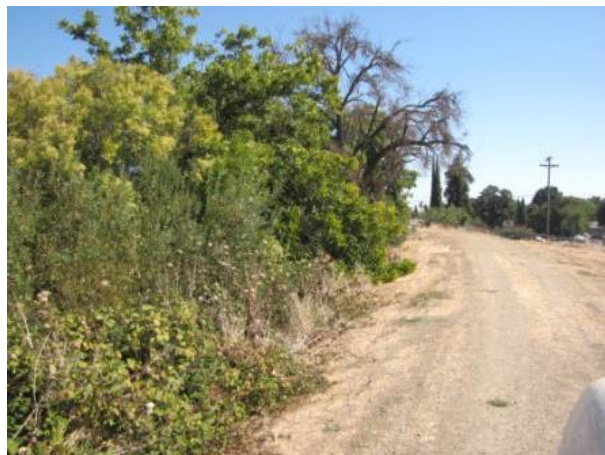
Levee Mile Report Line	170
Start Levee Mile	23.22
End Levee Mile	23.22
Location	Water Side
Category	Earthen Levee
Item	Vegetation

View of excessive vegetation along the waterward side of levee obstructing visibility and access looking upstream.

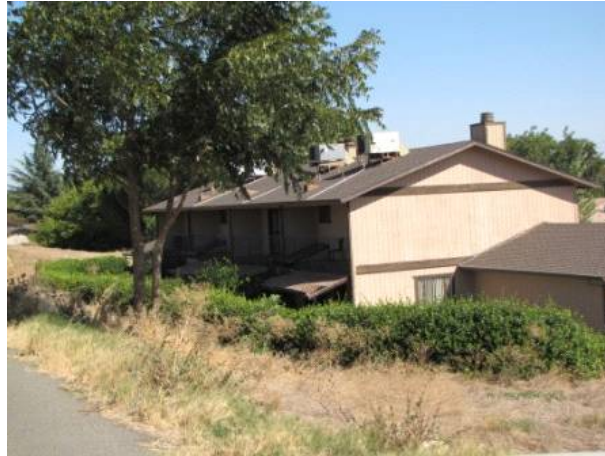
dpesaven_s_20100316_351.jpg

View of landscaping along the landward slope looking upstream.

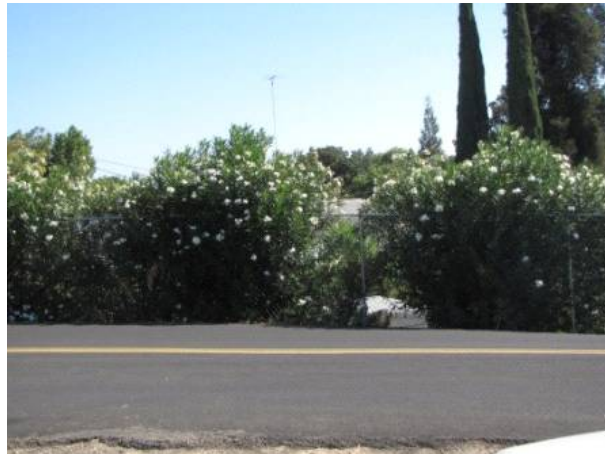
Levee Mile Report Line	172
Start Levee Mile	23.30
End Levee Mile	23.34
Location	Land Side
Category	Earthen Levee
Item	Encroachments

View of fence and landscaping along the landward slope.

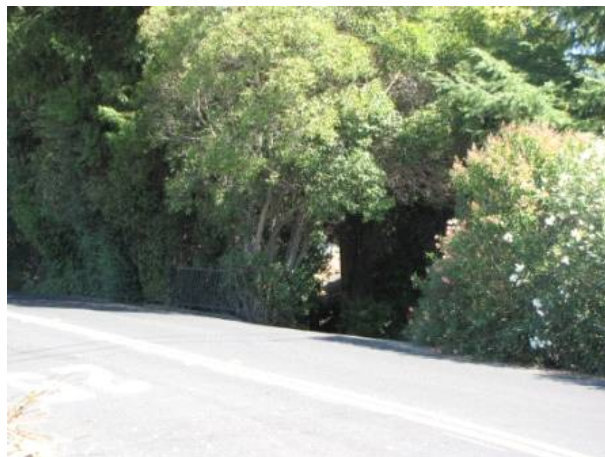
Levee Mile Report Line	173
Start Levee Mile	23.30
End Levee Mile	23.34
Location	Land Side
Category	Earthen Levee
Item	Encroachments

View of landscaping along the landward levee slope looking upstream.

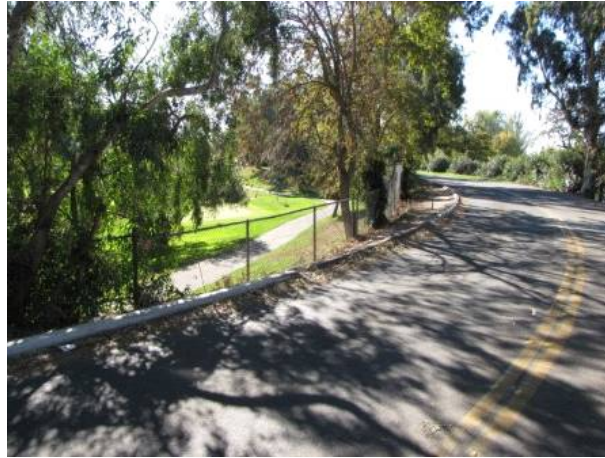
dpesaven_s_20100316_423.jpg

View of the fence along the landward slope looking downstream.

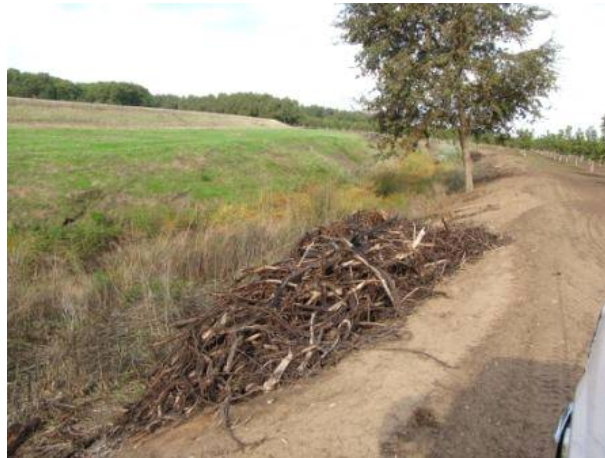
dpesaven_s_20100316_425.jpg

View of a prunings pile along the waterward bank looking downstream.

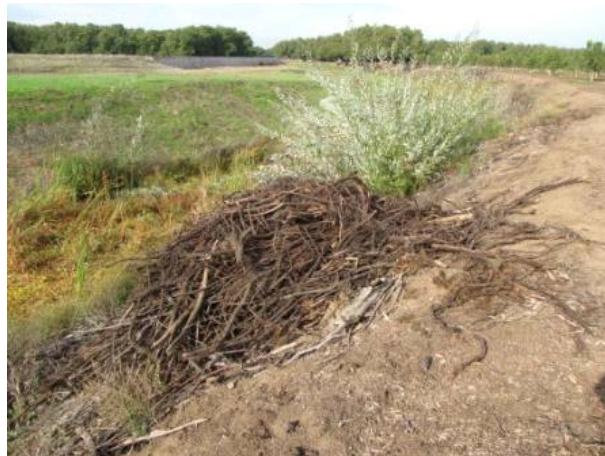
Levee Mile Report Line	2
Start Levee Mile	0.17
End Levee Mile	0.17
Location	Water Side
Category	Earthen Levee
Item	Encroachments

View of a prunings pile along the waterward bank looking downstream.

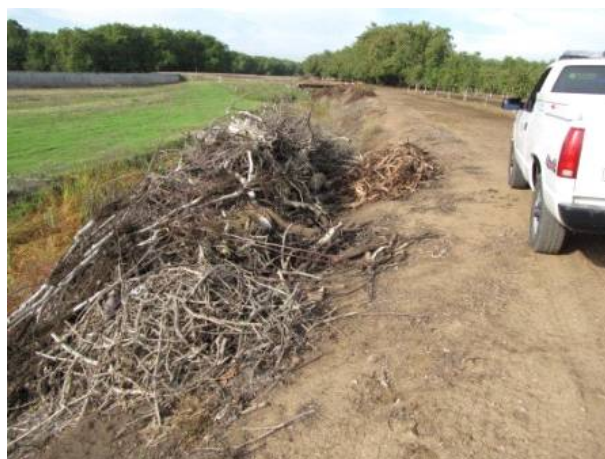
Levee Mile Report Line	3
Start Levee Mile	0.22
End Levee Mile	0.22
Location	Water Side
Category	Earthen Levee
Item	Encroachments

View of a prunings pile along the waterward bank looking downstream.

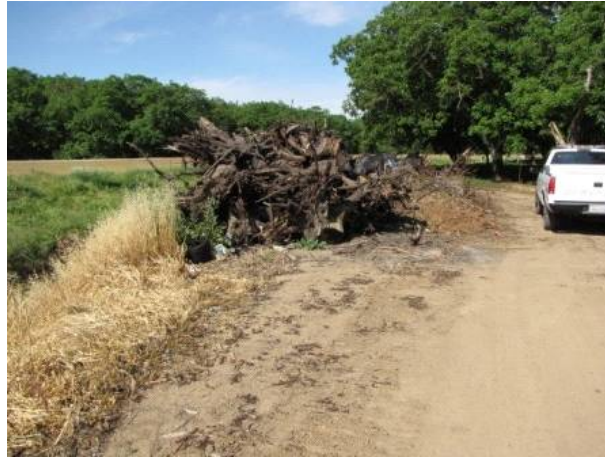
Levee Mile Report Line	6
Start Levee Mile	0.37
End Levee Mile	0.37
Location	Water Side
Category	Earthen Levee
Item	Encroachments
Debris pile located on waterside of levee at LM 0.50.	
dpesaven_s_20100316_424.jpg
